Quality Improvement Highlights for 2024

Brazed Plate Heat Exchanger Department

Fuel Cell Business

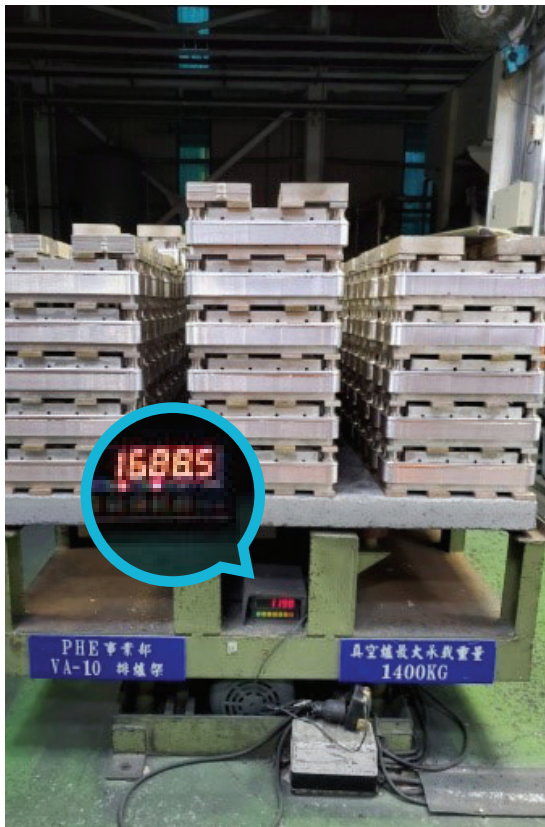
The status before improvement

Manual visual inspection used to determine total furnace load,

- Different equipment has different weight limits, previously judged manually by visual inspection to determine whether overweight.

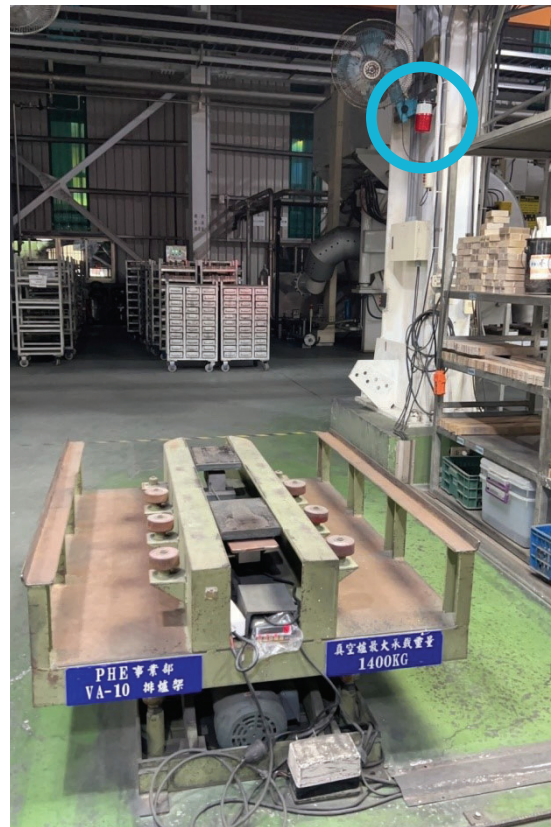
The result after improvement

Warning lights indicate when the load exceeds the limit

- Reduces the risk of human error
- Easy to read and ergonomically designed, eliminating the need to bend over.

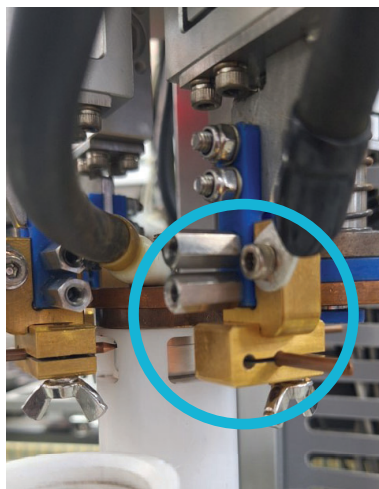
The result after improvement

- Improved fixture design by extending the lever arm to effectively secure the copper rods. Among nearly 70,000 products, the defect rate due to abnormal desoldering dropped to 0.76%.
- Replaced the original fastener with a butterfly screw tightened from bottom to top. This allows for quick replacement of worn copper rods in confined spaces without the use of tools.
